2022

ANNUAL WATER REPORT

City of Parksville
Operations

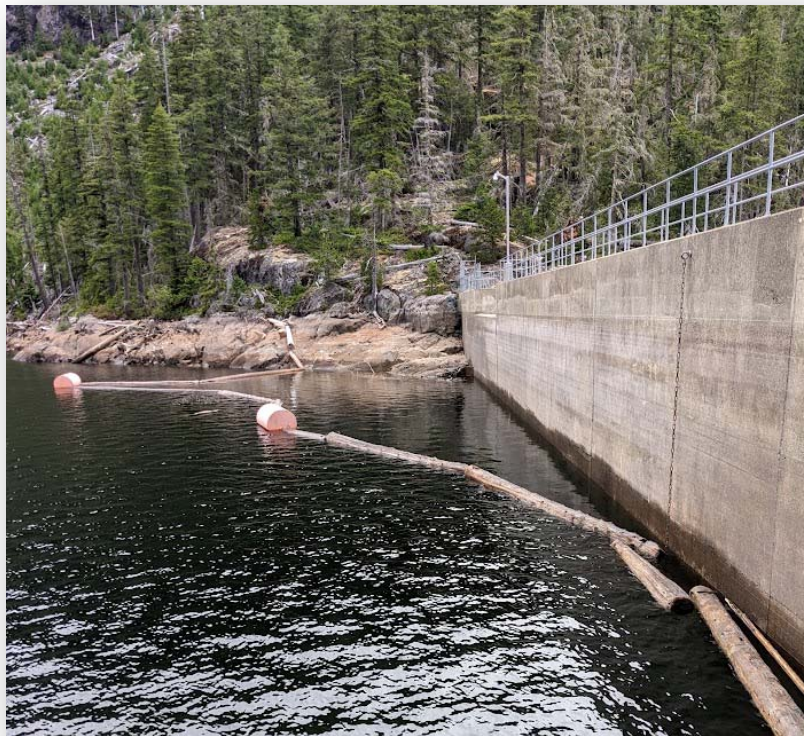
The City of Parksville, the Regional District of Nanaimo, and the Town of Qualicum Beach are partners in the Arrowsmith Water Service (AWS). The concrete gravity dam is located at Arrowsmith Lake, about nineteen kilometres (19 km) south of Parksville and commissioned in 2000. The dam has a capacity of 9,000,000 m³ and is operated and maintained by the City of Parksville utilities staff. Water is released to the Englishman River through two pipes, 900 mm and 600 mm in diameter. Flow and lake levels are monitored regularly by staff through the Supervisory Control and Data Acquisition (SCADA) system.

Appendix B shows the Arrowsmith Dam Lake levels. Ministry of Forests, and the Arrowsmith Water Service (AWS) are updating the provisional operating rule to conserve reservoir storage water for critical fisheries rearing periods. A minimum flow is released into the river based on this curve between June and October.

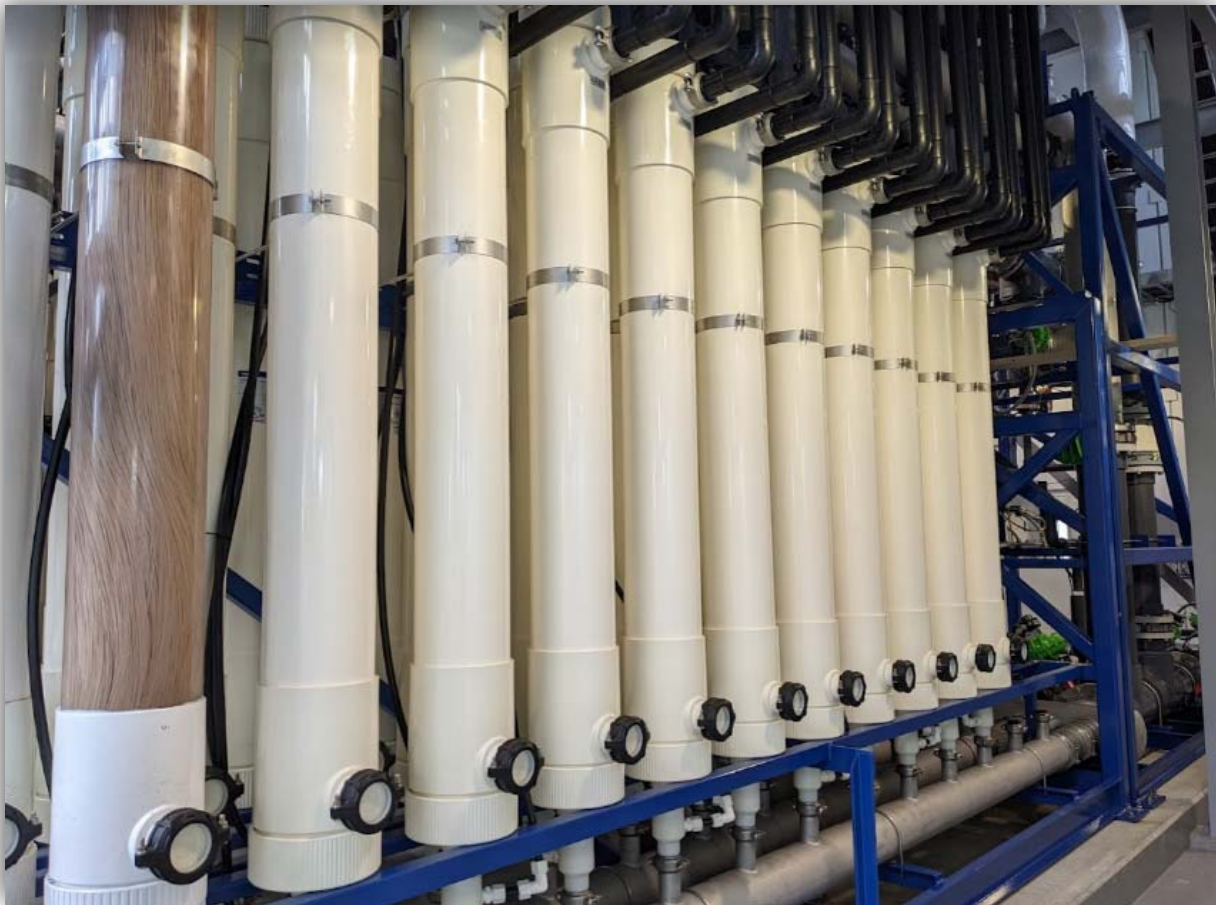
Ultrafiltration Membranes

Ultrafiltration (UF) membranes are used in a pressure driven separation process where microporous membranes remove contaminants (bacteria, viruses, Cryptosporidium and Giardia) from the water. The process forces water through the UF membranes, leaving contaminants behind. Once enough contaminants accumulate on the feed side of the membrane, a cleaning process occurs to bring the membrane back to a good working pressure. The first stage process recovers approximately 95% of the water. The second stage membrane, when in use, can recover up to 99% of the total water. However, due to operational issues, the second stage membrane was not used in 2022.

Both ultraviolet (UV) and chlorination disinfection processes are used on the finished water. Ultraviolet disinfection inactivates Cryptosporidium, Giardia, and viruses. UV light disinfects water by altering the DNA or RNA of pathogens and destroys their ability to reproduce. Chlorination inactivates viruses. pH adjustment is followed thereafter, from the above steps and before it gets pumped into the reservoirs which then goes to the distribution system. The water is continually sampled to provide water quality assurance and to meet regulatory requirements.

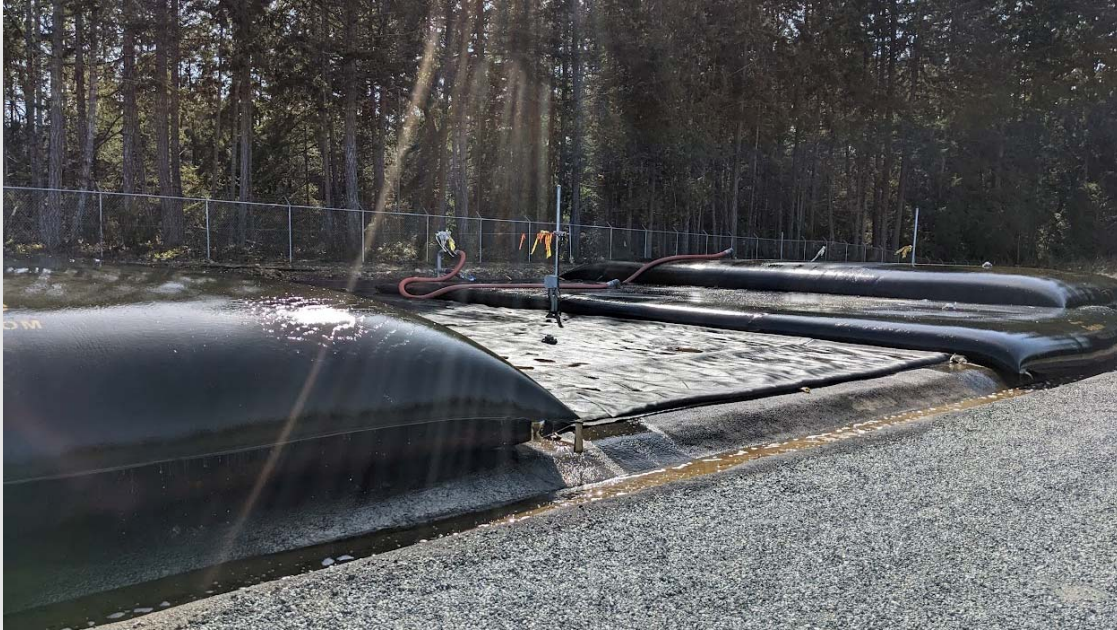
Geobags

The waste water produced from the backwashing of the membranes are treated on site using Geotubes. These dewatering cells, along with the addition of a polymer, bind the small particles from the waste into larger ones that are filtered out. The solids stay in the bags, the water percolates out. When these bags are full the material will be transported to the landfill to be used as cover material.

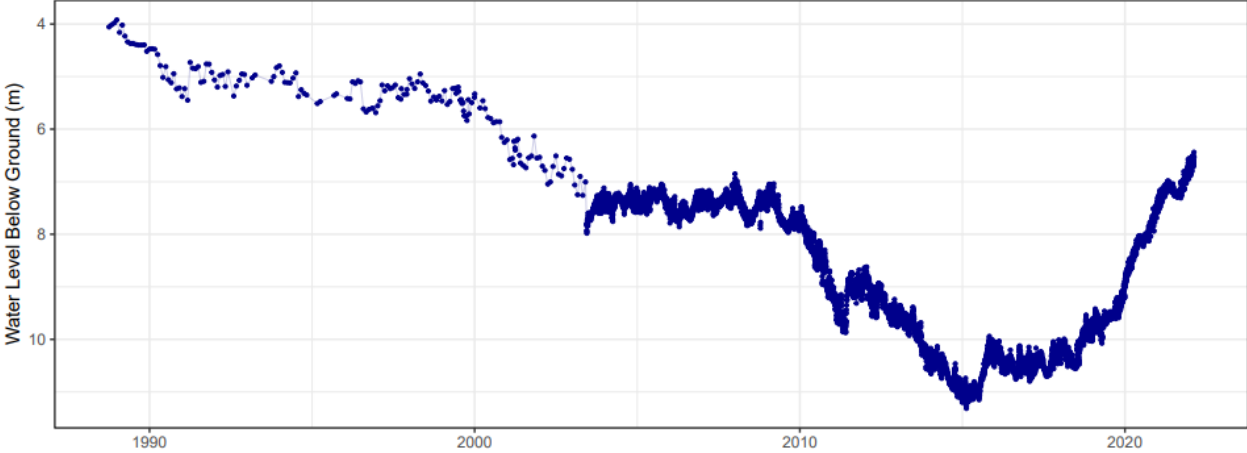
OBS WELL 304
Water Level Snapshot

Observation wells #304 and #398 are showing signs of recovery. These wells are in the same aquifer as the City of Parksville Springwood and Railway Wells.

Note: True data are marked with a dot, the thin line connecting points is a visual aid only and does not represent true observations. The full data set can be downloaded via the BC Data Catalogue or the BC Real-time Water Data tool.

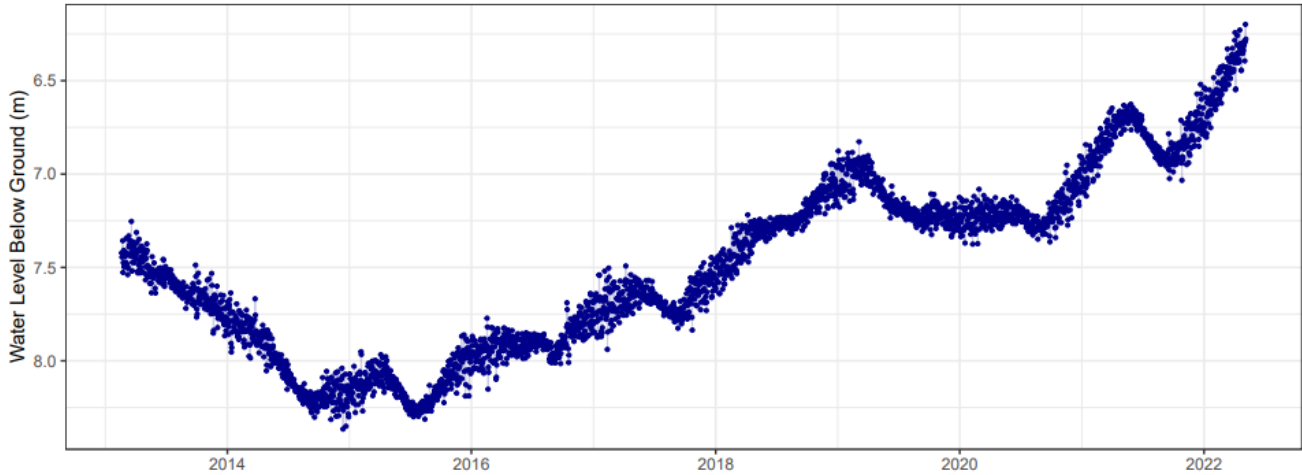
OBS WELL 398
Water Level Snapshot

Note: True data are marked with a dot, the thin line connecting points is a visual aid only and does not represent true observations. The full data set can be downloaded via the BC Data Catalogue or the BC Real-time Water Data tool.

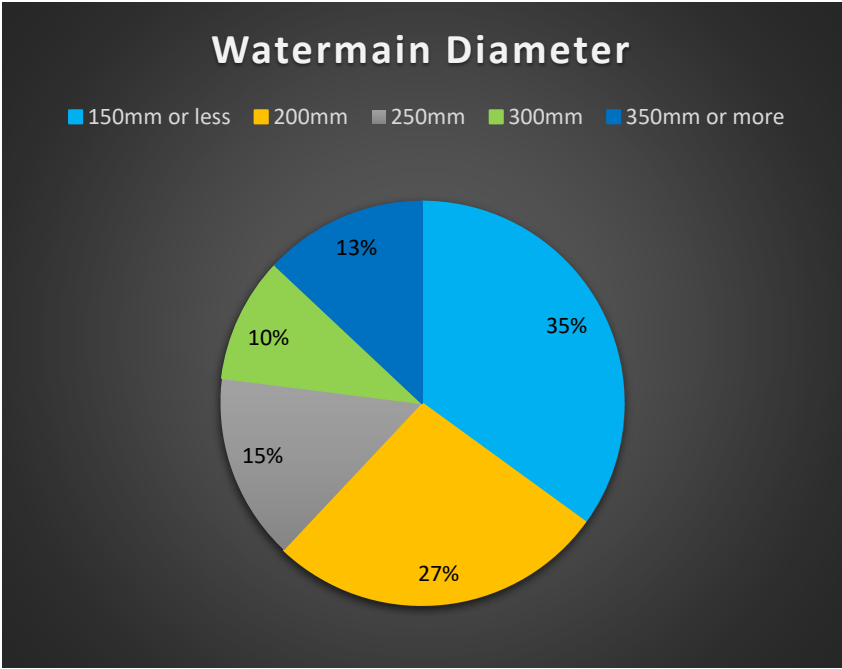
2022 Watermain Diameter Proportions

Diameter	N° of Pipes	Distance (km)	Percentage	Type
150mm or less	676	39.39	35%	Distribution Main 62%
200mm	614	30.5	27%	
250mm	286	16.47	15%	Supply Mains 38%
300mm	209	11.8	10%	
350mm or more	178	14.26	13%	
Total		112.42 km

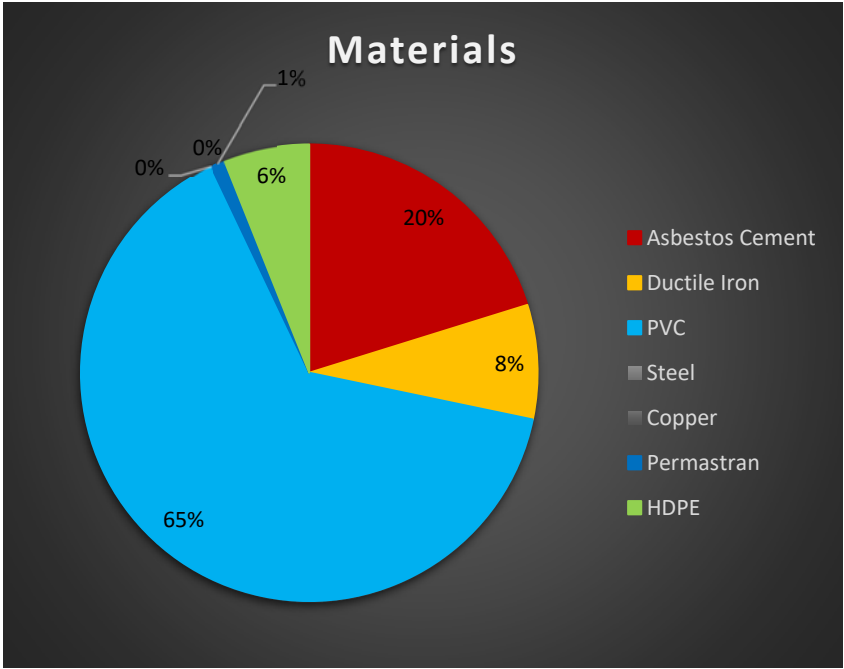
2022 Watermain Material Proportions

Material Type	Distance (km)	Percentage
AC	22.7	20%
Ductile Iron	9.3	8%
PVC	72.2	64%
Steel	0.8	0%
Copper	0.1	0%
Permastran	0.7	1%
HDPE	6.6	6%
Total	112.42km

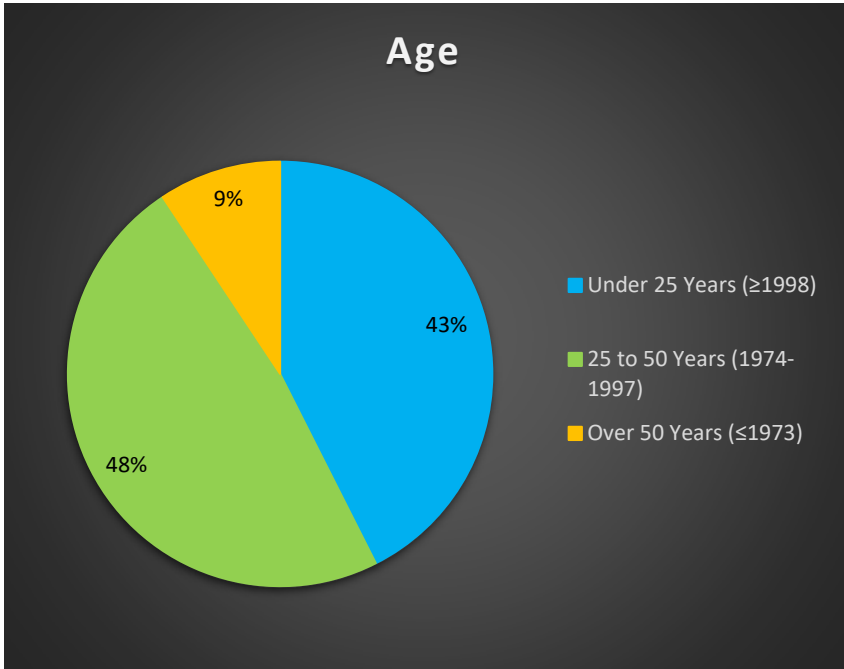
2022 Watermain Age Proportions

Age	N° of Pipes	Distance (km)	Percentage
Under 25 Years (≥ 1998)	996	47.83	43%
25 to 50 Years (1974-1997)	847	54.1	48%
Over 50 Years (≤ 1973)	120	10.49	9%
Total	112.42 km

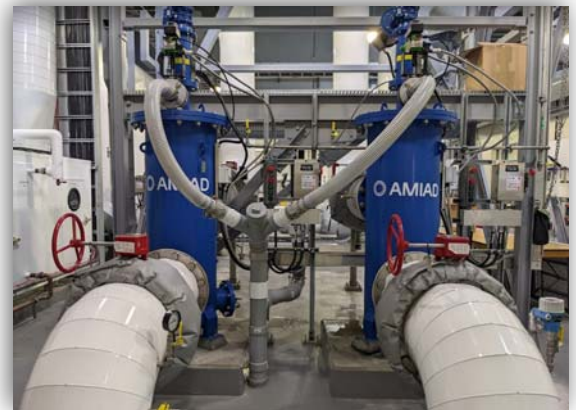
Strainers at the Water Treatment Plant

- Monitor and ensure coagulant dosing is carrying out properly. Flush and clean the line when not in use
- Monitor strainer's differential pressure and check for leaks. Service and conduct maintenance to improve system performance

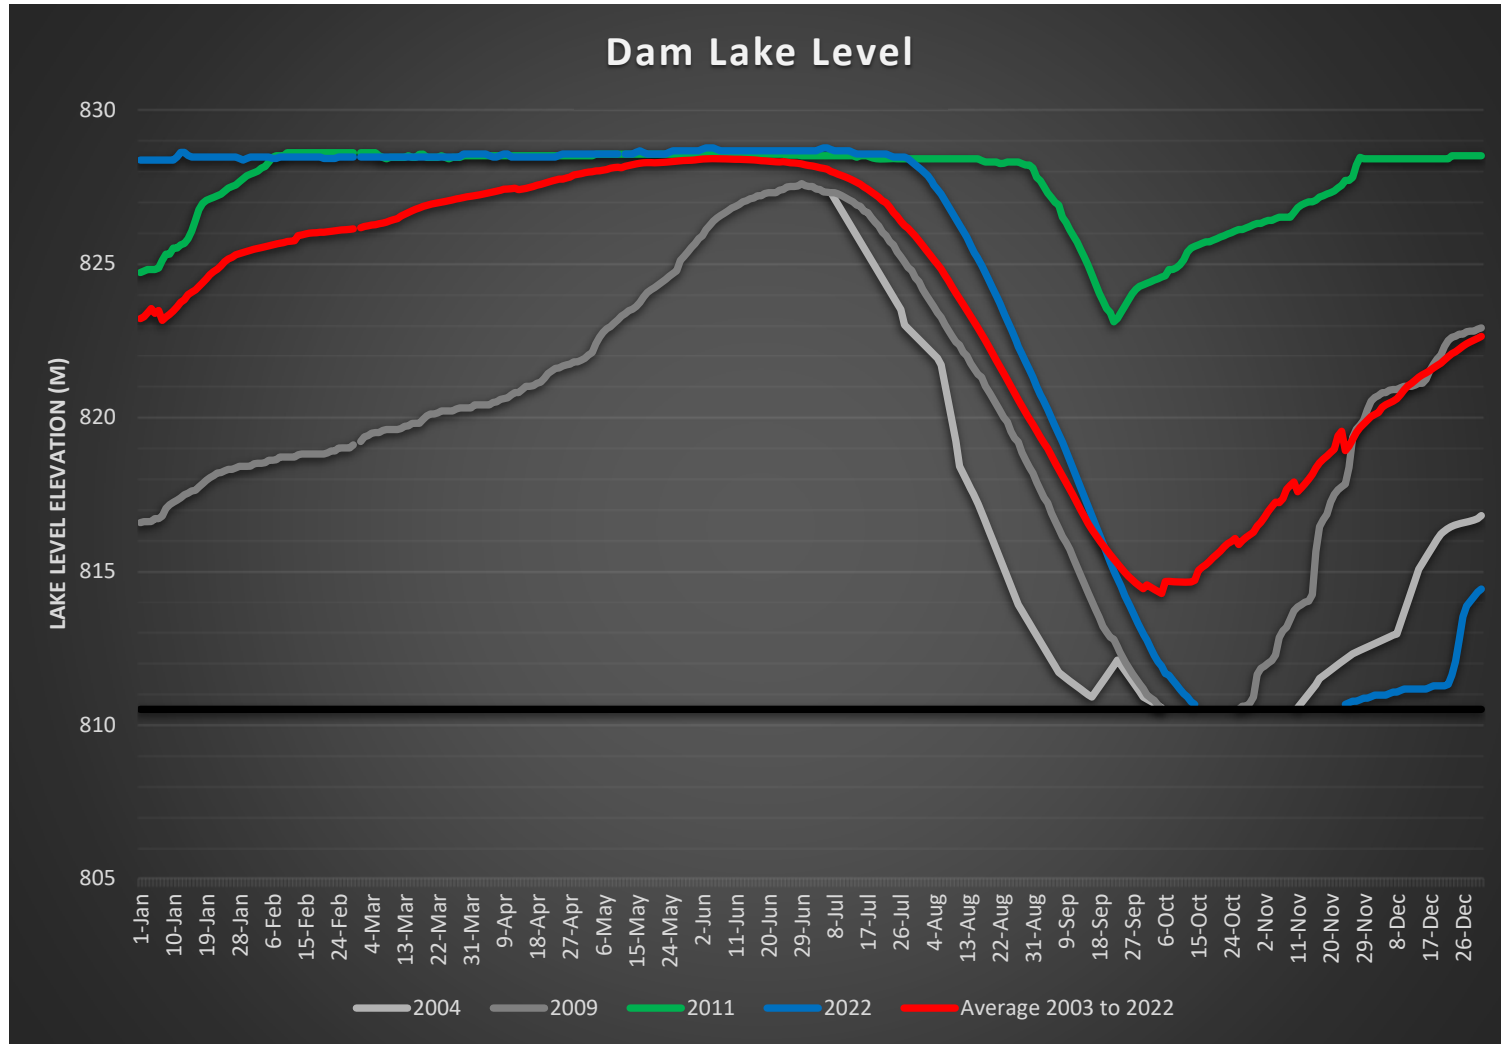
Appendix B - Dam Lake Levels

The logger is set to read the lake level only until the High-level outlet elevation, shown below as the purple line.
