City of  
**Parksville**  
Engineering & Operations Department

**ANNUAL WATER REPORT**

**December 2008**

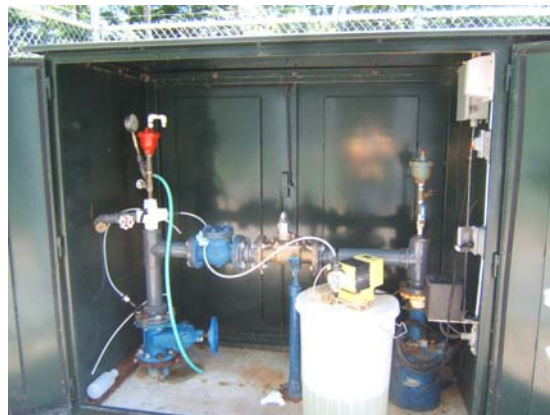
Railway Well Kiosk No. 5

## 2.1 Groundwater Wells:

The City's groundwater is pumped from a confined quadra sands aquifer that runs underground alongside the railway tracks from Trill Drive to the City's boundary in the southwest. The City currently has 16 production wells ranging from 1.4 l/s (18 IGPM) to 9.2 l/s (121 IGPM).

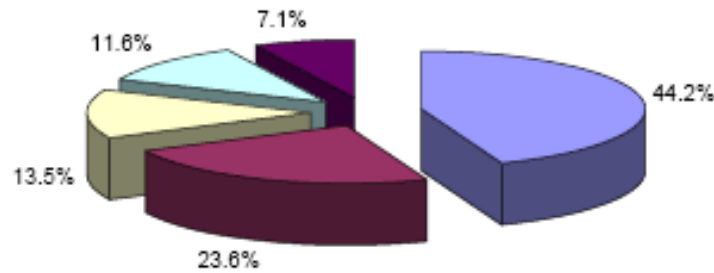
2008 Watermains - Proportions of Diameter

2008 Watermains Proportions of Diameter				
Diameter	No Pipes	Distance (km)	Percentage	Type
150mm or less	559	41.960	44.2%	Distribution Mains
200mm	336	22.467	23.6%	
250mm	166	12.830	13.5%	Supply Mains
300mm	142	11.000	11.6%	
Greater than 350mm	80	6.757	7.1%	
<b>Total:</b>	<b>1283</b>	<b>95.014</b>	<b>km</b>

Like all municipalities, the infrastructure is aging and watermains are being replaced through capital improvements. The following shows the size, age and material of the mains in the Parksville Water System

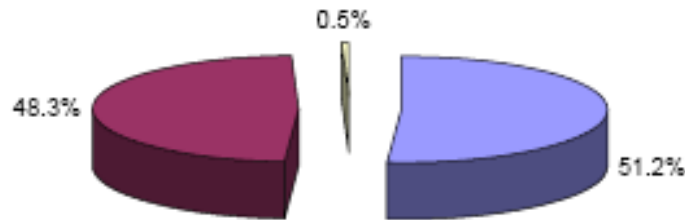
2008 Watermains - Proportions of Age

2008 Watermains Proportions of Age			
Age	No Pipes	Distance (km)	Percentage
Under 25 Years (>1983)	696	48.676	51.2%
25 - 50 Years (1958 to 1982)	559	45.862	48.3%
Over 50 Years (<1958 or = 0)	28	0.478	0.5%
<b>Total:</b>	<b>1283</b>	<b>95.014</b>	<b>km</b>

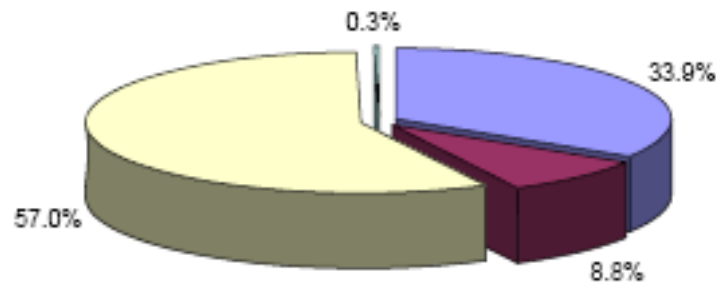
2008 Watermain Materials Proportions

2008 Watermains Proportions of Materials		
Material Types	Distance (km)	Percentage
Asbestos Cement	32.184	33.9%
Ductile Iron	8.318	8.8%
PVC	54.188	57.0%
Steel	0.327	0.3%
<b>Total:</b>	<b>95.014</b>	<b>km</b>

The distribution system consists of 54 km of PVC (plastic) pipe, 8.3 km of Ductile Iron pipe and 32 km of AC (Asbestos Cement) pipe. Sizes range from 4" to 14".

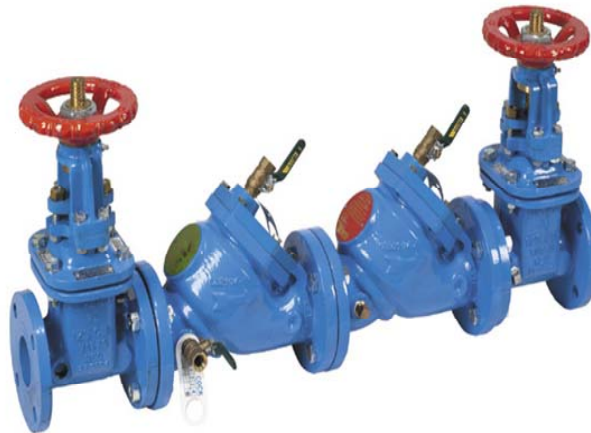
Double Detector Check Valve

The cross connection program will be implemented in a manner that will address high and severe hazard water use processes first. These include Industrial, Commercial and Institutional (ICI) users. Each ICI user will be assessed as to the potential risk to the water system. An approved backflow device will have to be installed.

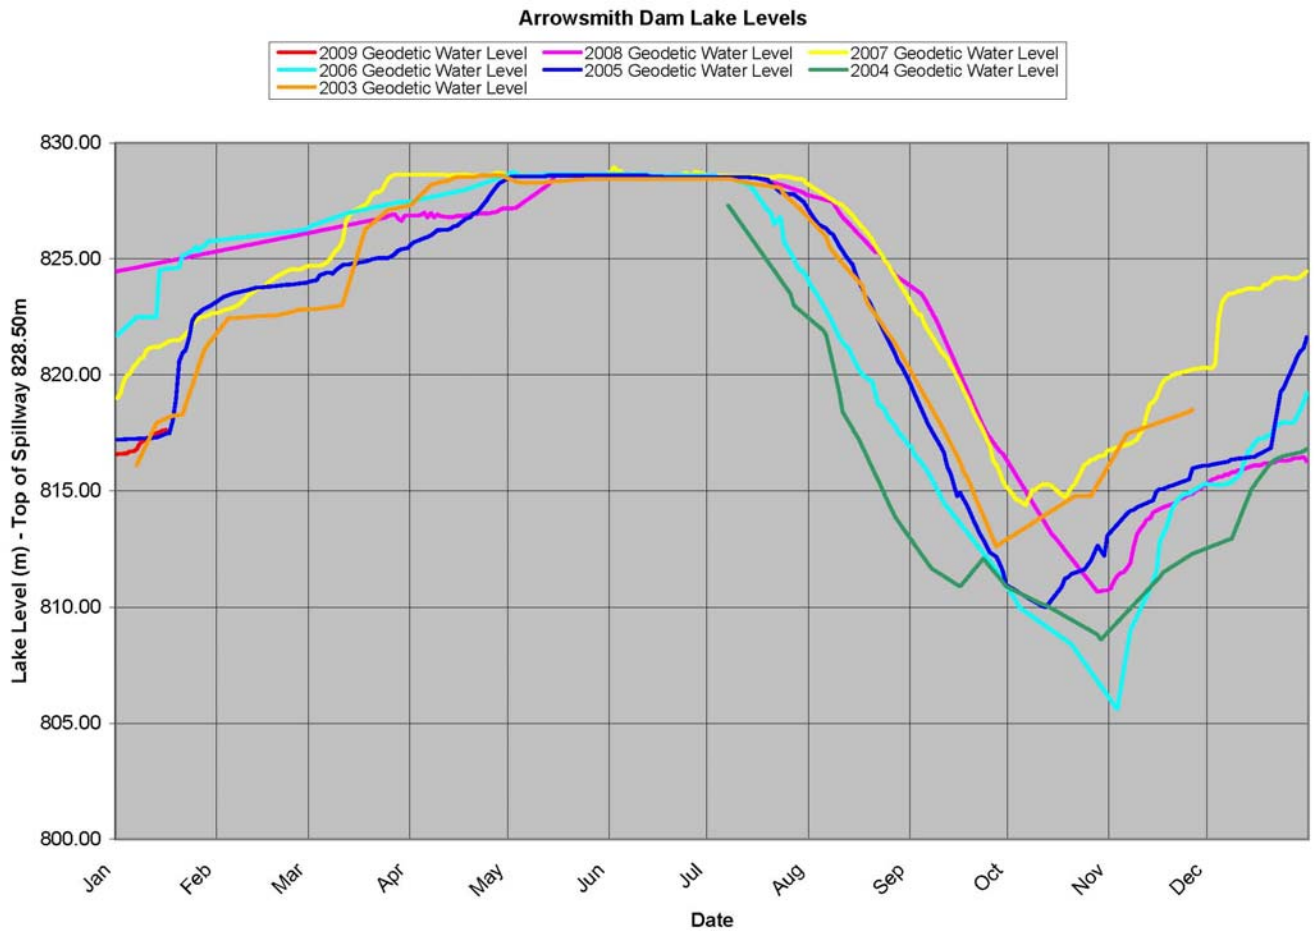
## Arrowsmith Dam Lake Levels 2003 - 2009

The City of Parksville, The Regional District of Nanaimo, and The Town of Qualicum are partners in the Arrowsmith Water Service (AWS). The dam is located at Arrowsmith Lake approximately 19km south of Parksville. It was commissioned in September 2000. The dam has a capacity of 9,000,000 m<sup>3</sup> and is operated and maintained by City of Parksville staff. Water is released to the Englishman river through 2 pipes, a 900 mm and a 600 mm with flows and lake levels monitored by the City's Supervisory Control and Data Acquisition (SCADA) system.

See **Appendix B** for Arrowsmith Dam Lakes Levels 2003 – 2009.
